A steel mill achieves a 96% cost savings in just one year with the GPM-Eliminator.

The GPM-Eliminator Handles Mill Scale With Ease. A “Two For One” Success Story

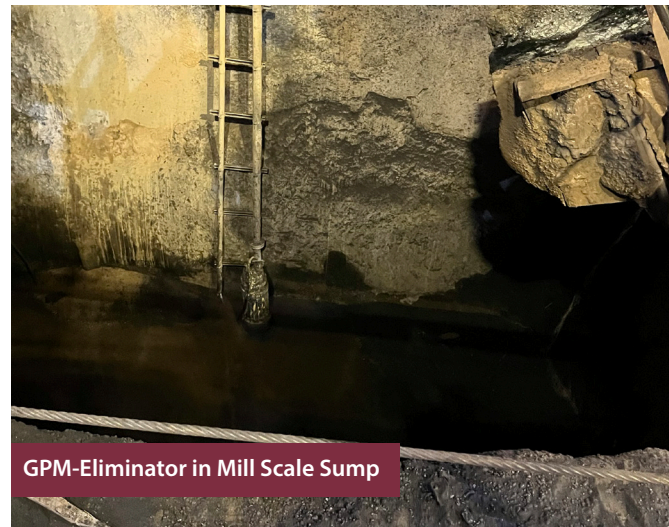
GPM-Eliminator in Mill Scale Sump

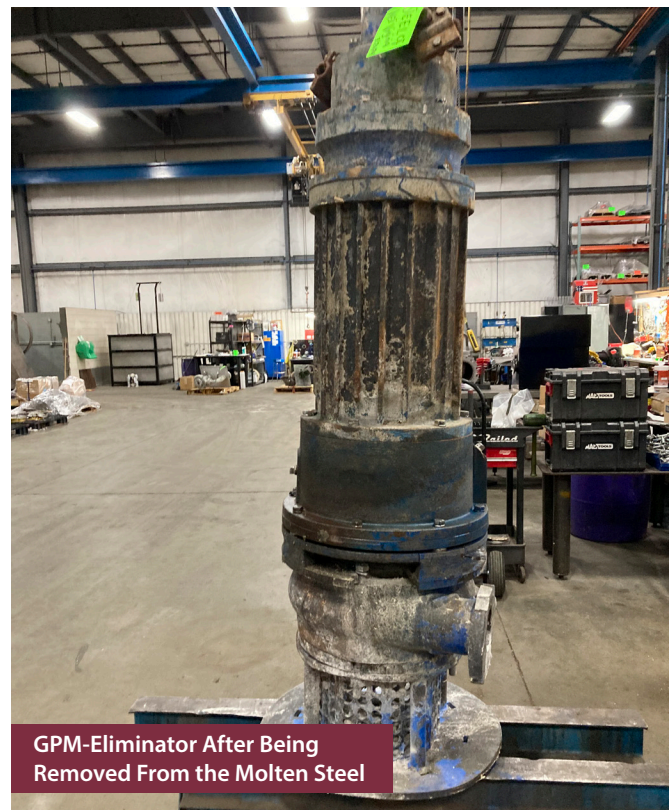
GPM-Eliminator After Being
Removed From the Molten Steel

With the wet end of the pump removed, the shaft and rotor spun freely. The grease in the lower bearing had been burnt up by the molten steel, but since the pump had not been running after the steel was poured into the sump there was no significant damage on the rotating assembly (the rotor, shaft, and impeller).

Despite this setback, a minor repair involving the replacement of bearings, seals, O-rings, cable assembly, and a stator baking and dipping process would have essentially restored the pump to its original equipment manufacturer (OEM) specifications and tolerances. Upon dismantling the pump, it was evident that its internals had held up admirably against the harsh scale, suggesting that it would have likely continued operating smoothly for many more months, if not over a year.

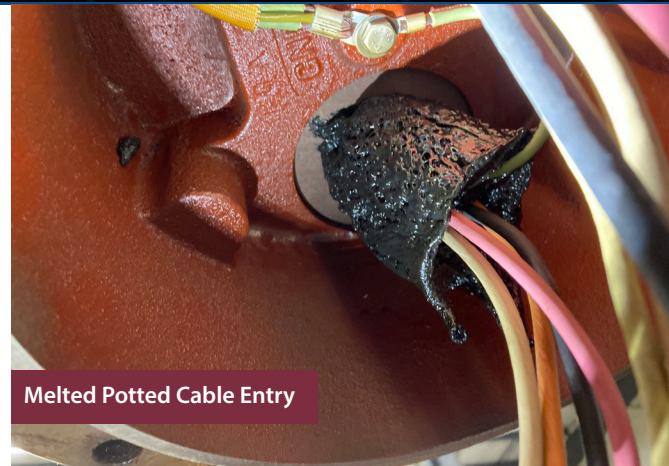
Melted Potted Cable Entry

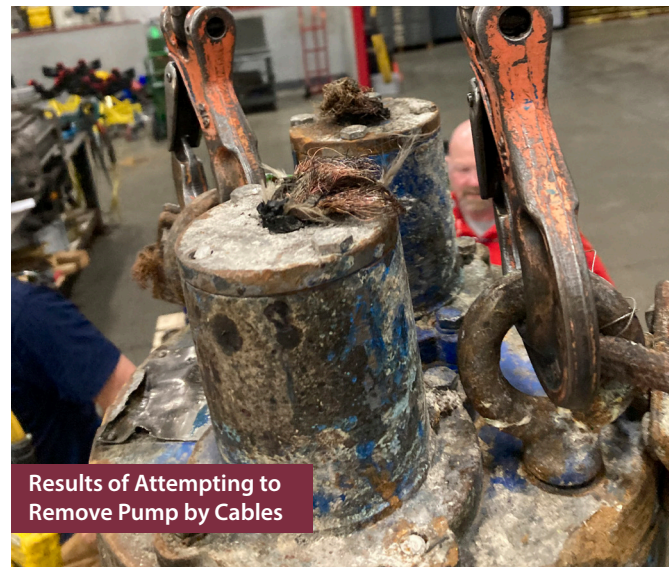
Results of Attempting to Remove Pump by Cables

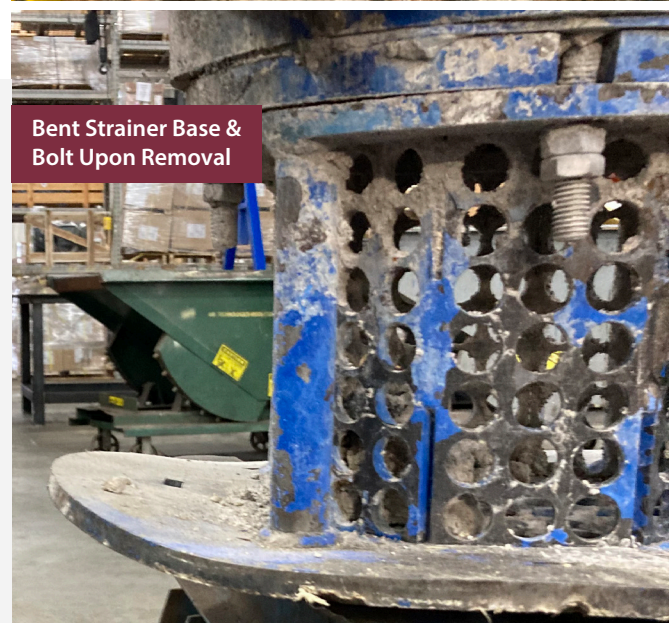
Bent Strainer Base & Bolt Upon Removal
